**Flood Control Project Maintenance  
Levee Inspections**  
**LMA District Cover Sheet**  
**Spring 2020 Levee Inspection Results**

**American River Flood Control District**

**Spring 2020 Levee Inspection Results**

Waterway			Bank	Unit Miles
Unit No. 01 Arcade Creek			Left	2.08
	Spring (March - May)	Summer (June - August)	(September - November) Fall	Winter (December - February)
Unit Maintenance Rating (Fall Only)				
Date of Inspection	3/25/2020 - 3/25/2020			
DWR Inspector	Luz Dial			
Accompanied By	Gilbert Gutierrez ARFCD

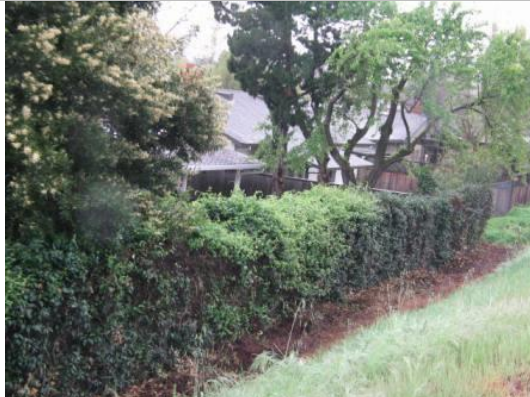
Photo 1 of 1 : SP\_2020\_NA0001\_55\_107\_20200302\_00087.jpg

LM Start	8.47	Rating **	U	Issue No.	107
LM End	8.47	Issue Type +	En	Location *	LS
Category	Earthen Levee			GPS Latitude/Longitude	
				Start	End
Item	Vegetation			38.563511 °	38.563511 °
				-121.389509 °	-121.389509 °
DWR ID	DWR_NA0001_04_s_2012_107				
Comment Code					
V6 : Landscaping					
Inspector Comment

03/16/2012 Landscaping obstructs visibility and access.

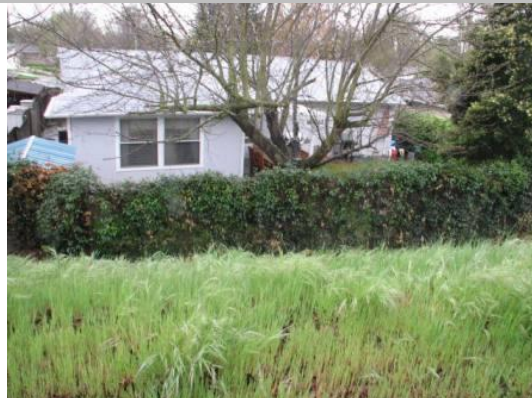
Photo 1 of 1 : SP\_2020\_NA0001\_55\_108\_20200302\_00088.jpg

LM Start	8.48	Rating **	U	Issue No.	108
LM End	8.48	Issue Type +	En	Location *	LS
Category	Earthen Levee			GPS Latitude/Longitude	
				Start	End
Item	Vegetation			38.563482 °	38.563482 °
				-121.389368 °	-121.389368 °
DWR ID	DWR_NA0001_04_s_2019_108				
Comment Code					
V6 : Landscaping					
Inspector Comment					
Chainlink fence and landscaping block visibility and access.

03/16/2012 Landscaping obstructs visibility and access.

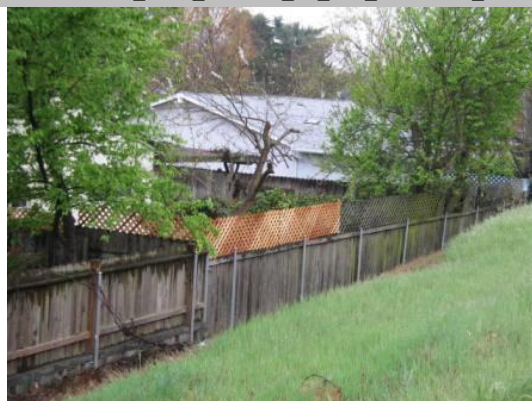
Photo 1 of 1 : SP\_2020\_NA0001\_55\_109\_20200302\_00089.jpg

LM Start	8.49	Rating **	U	Issue No.	109
LM End	8.49	Issue Type +	En	Location *	LS
Category	Earthen Levee			GPS Latitude/Longitude	
				Start	End
Item	Encroachments			38.563580 °	38.563580 °
				-121.389140 °	-121.389140 °
DWR ID	DWR_NA0001_04_s_2012_109				
Comment Code					
FE : Fence					
Inspector Comment					
Wood privacy fence within 10-ft of levee toe obstructs access and visibility.

03/16/2012 Wood privacy fence completely obstructs access and visibility.

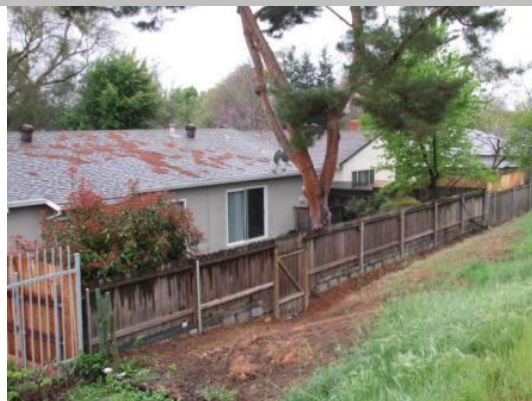
Photo 1 of 1 : SP\_2020\_NA0001\_55\_110\_20200302\_00090.jpg

LM Start	8.51	Rating **	U	Issue No.	110
LM End	8.51	Issue Type +	En	Location *	LS
Category	Earthen Levee			GPS Latitude/Longitude	
				Start	End
Item	Encroachments			38.563732 °	38.563732 °
				-121.388930 °	-121.388930 °
DWR ID	DWR_NA0001_04_s_2012_110				
Comment Code					
FE : Fence					
Inspector Comment					
Wood privacy fence within 10-ft of levee toe obstructs visibility.

03/16/2012 Wood privacy fence completely obstructs access and visibility.

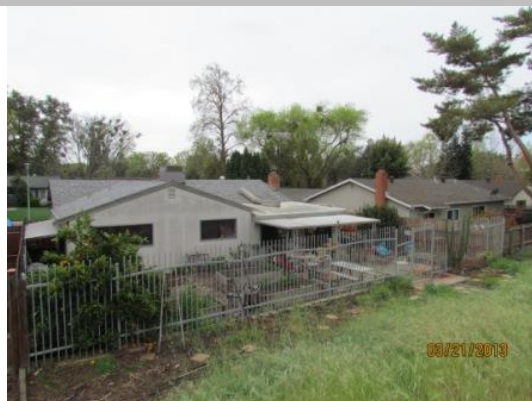
Photo 1 of 1 : SP\_2020\_NA0001\_55\_226\_20200302\_00178.jpg

LM Start	8.52	Rating **	M	Issue No.	226
LM End	8.52	Issue Type +	En	Location *	LS
Category	Earthen Levee			GPS Latitude/Longitude	
				Start	End
Item	Vegetation			38.563793 °	38.563793 °
				-121.388758 °	-121.388758 °
DWR ID	DWR_NA0001_04_s_2012_226				
Comment Code					
V6 : Landscaping					
Inspector Comment					
Garden, trees, and cactus are planted within the levee toe easement.

View of landscaping at the levee toe.

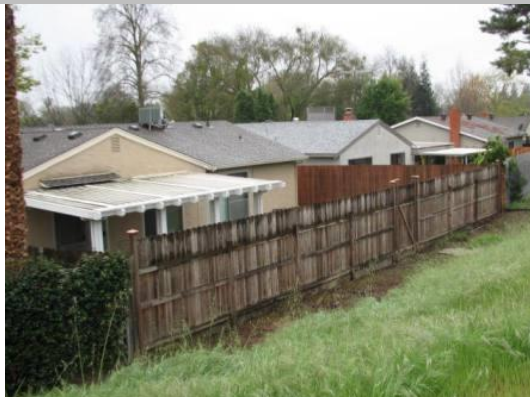
Photo 1 of 1 : SP\_2020\_NA0001\_55\_111\_20200302\_00091.jpg

LM Start	8.53	Rating **	U	Issue No.	111
LM End	8.53	Issue Type +	En	Location *	LS
Category	Earthen Levee			GPS Latitude/Longitude	
				Start	End
Item	Encroachments			38.563820 °	38.563820 °
				-121.388518 °	-121.388518 °
DWR ID	DWR_NA0001_04_s_2012_111				
Comment Code					
FE : Fence					
Inspector Comment					
Wood privacy fence within 10-ft of levee toe obstructs access and visibility.

03/16/2012 Wood privacy fence completely obstructs access and visibility.

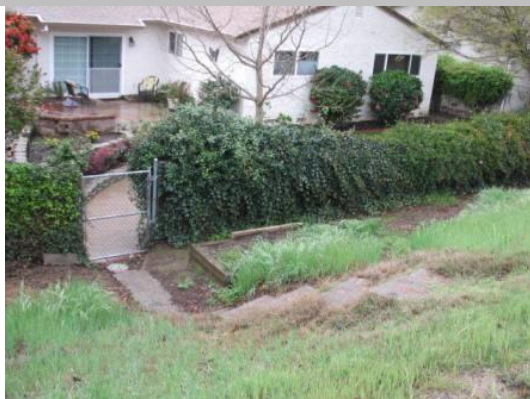
Photo 1 of 1 : SP\_2020\_NA0001\_55\_113\_20200302\_00093.jpg

LM Start	8.55	Rating **	U	Issue No.	113
LM End	8.55	Issue Type +	En	Location *	LS
Category	Earthen Levee			GPS Latitude/Longitude	
				Start	End
Item	Vegetation			38.563963 °	38.563963 °
				-121.388135 °	-121.388135 °
DWR ID	DWR_NA0001_04_s_2012_113				
Comment Code					
V6 : Landscaping					
Inspector Comment

03/16/2012 Landscaping on chainlink fence blocks visibility and access.

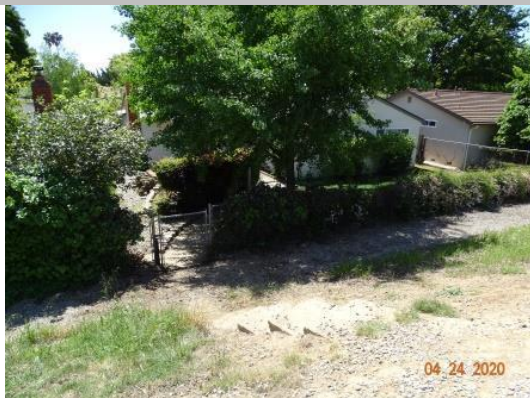
Photo 1 of 1 : SP\_2020\_NA0001\_55\_311\_20200427\_00278.jpg

LM Start	8.56	Rating **	M	Issue No.	311
LM End	8.56	Issue Type +	En	Location *	LS
Category	Earthen Levee			GPS Latitude/Longitude	
				Start	End
Item	Encroachments			38.563970 °	38.563970 °
				-121.388018 °	-121.388018 °
DWR ID	DWR_NA0001_04_s_2020_311				
Comment Code					
ST : Stairway					
Inspector Comment					
Concrete steps were placed on the landside slope.

View of concrete steps on the landside slope. Spring 2020

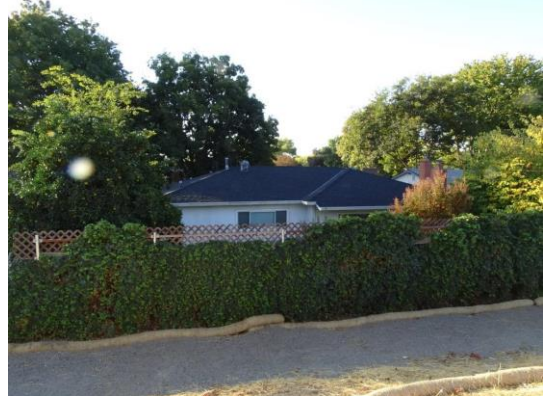
Photo 1 of 1 : SP\_2020\_NA0001\_55\_114\_20200302\_00094.jpg

LM Start	8.57	Rating **	U	Issue No.	114
LM End	8.57	Issue Type +	En	Location *	LS
Category	Earthen Levee			GPS Latitude/Longitude	
				Start	End
Item	Vegetation			38.564020 °	38.564020 °
				-121.387887 °	-121.387887 °
DWR ID	DWR_NA0001_04_s_2012_114				
Comment Code					
V6 : Landscaping					
Inspector Comment					
Ivy on a fence and an orange tree obstruct visibility.

View of fence with added lattice that obstructs visibility and access. Fall 2018

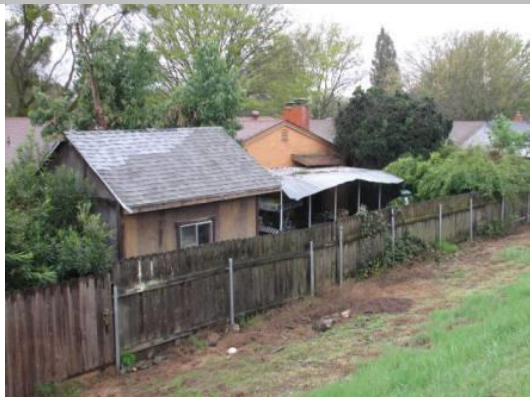
Photo 1 of 1 : SP\_2020\_NA0001\_55\_117\_20200302\_00097.jpg

LM Start	8.59	Rating **	U	Issue No.	117
LM End	8.59	Issue Type +	En	Location *	LS
Category	Earthen Levee			GPS Latitude/Longitude	
				Start	End
Item	Encroachments			38.564094 °	38.564094 °
				-121.387498 °	-121.387498 °
DWR ID	DWR_NA0001_04_s_2012_117				
Comment Code					
FE : Fence					
Inspector Comment					
Wood privacy fence within 10-ft of levee toe obstructs access and visibility.

03/16/2012 Wood privacy fence completely obstructs access and visibility.

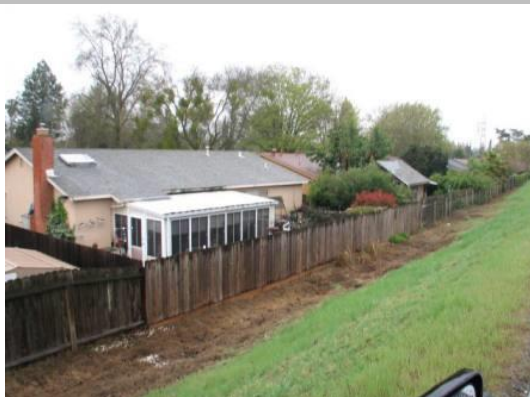
Photo 1 of 1 : SP\_2020\_NA0001\_55\_116\_20200302\_00096.jpg

LM Start	8.60	Rating **	U	Issue No.	116
LM End	8.60	Issue Type +	En	Location *	LS
Category	Earthen Levee			GPS Latitude/Longitude	
				Start	End
Item	Encroachments			38.564133 °	38.564133 °
				-121.387318 °	-121.387318 °
DWR ID	DWR_NA0001_04_s_2012_116				
Comment Code					
FE : Fence					
Inspector Comment					
Wood privacy fence within 10-ft of levee toe obstructs access and visibility.

03/16/2012 Wood privacy fence completely obstructs access and visibility.

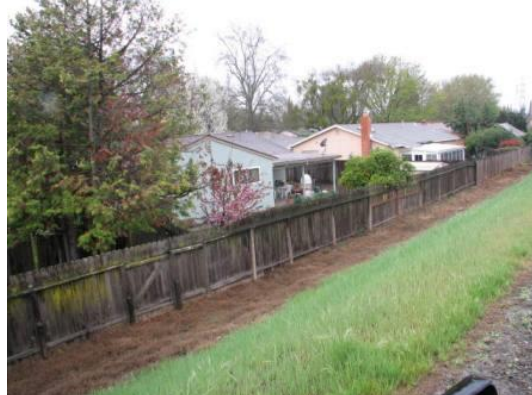
Photo 1 of 1 : SP\_2020\_NA0001\_55\_118\_20200302\_00098.jpg

LM Start	8.61	Rating **	U	Issue No.	118
LM End	8.61	Issue Type +	En	Location *	LS
Category	Earthen Levee			GPS Latitude/Longitude	
				Start	End
Item	Encroachments			38.564133 °	38.564133 °
				-121.387092 °	-121.387092 °
DWR ID	DWR_NA0001_04_s_2018_118				
Comment Code					
FE : Fence					
Inspector Comment					
Wood privacy fence within 10-ft of levee toe obstructs access and visibility.

03/16/2012 Wood privacy fence completely obstructs access and visibility.

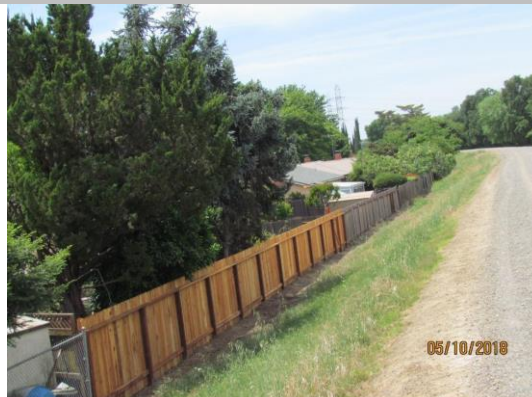
Photo 1 of 1 : SP\_2020\_NA0001\_55\_119\_20200302\_00099.jpg

LM Start	8.63	Rating **	U	Issue No.	119
LM End	8.63	Issue Type +	En	Location *	LS
Category	Earthen Levee			GPS Latitude/Longitude	
				Start	End
Item	Encroachments			38.564217 °	38.564217 °
				-121.386846 °	-121.386846 °
DWR ID	DWR_NA0001_04_s_2012_119				
Comment Code					
FE : Fence					
Inspector Comment					
Wood privacy fence completely obstructs access and visibility.

New wood privacy fence still completely obstructs access and visibility, Spring 2018.

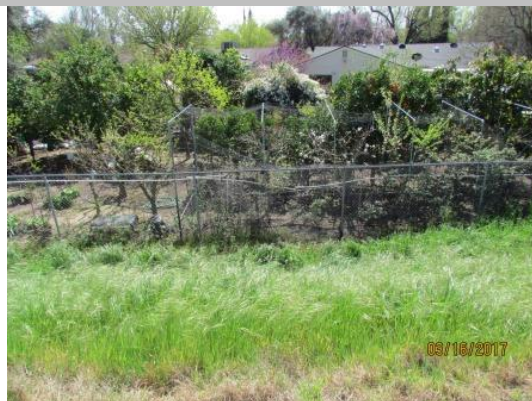
Photo 1 of 1 : SP\_2020\_NA0001\_55\_254\_20200302\_00192.jpg

LM Start	8.64	Rating **	M	Issue No.	254
LM End	8.65	Issue Type +	En	Location *	LS
Category	Earthen Levee			GPS Latitude/Longitude	
				Start	End
Item	Encroachments			38.564257 °	38.564330 °
				-121.386543 °	-121.386398 °
DWR ID	DWR_NA0001_04_s_2017_254				
Comment Code					
FE : Fence					
Inspector Comment					
Chain link fence blocks access.

View of the fence at the levee toe.

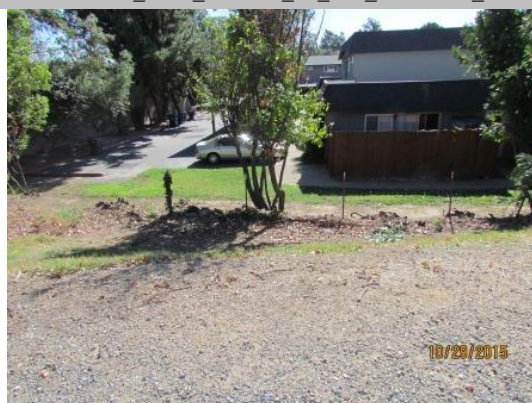
Photo 1 of 1 : SP\_2020\_NA0001\_55\_230\_20200302\_00182.jpg

LM Start	8.83	Rating **	N	Issue No.	230
LM End	8.83	Issue Type +	Ma	Location *	LS
Category	Earthen Levee			GPS Latitude/Longitude	
				Start	End
Item	Trim / Thin Trees			38.564929 °	38.564929 °
				-121.383248 °	-121.383248 °
DWR ID	DWR_NA0001_04_f_2015_230				
Comment Code					
T5 : Tree stumps.					
Inspector Comment					
There are five shrub stumps with multiple branches at this location.

View of the multiple tree stumps at the landside levee toe.

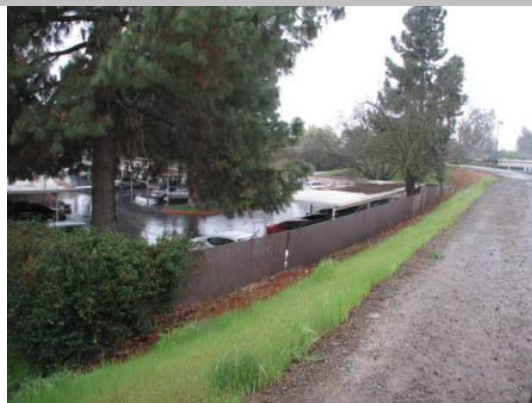
Photo 1 of 1 : SP\_2020\_NA0001\_55\_235\_20200302\_00184.jpg

LM Start	8.91	Rating **	U	Issue No.	235
LM End	8.91	Issue Type +	En	Location *	LS
Category	Earthen Levee			GPS Latitude/Longitude	
				Start	End
Item	Encroachments			38.565390 °	38.565390 °
				-121.381906 °	-121.381906 °
DWR ID	DWR_NA0001_04_s_2012_235				
Comment Code					
FE : Fence					
Inspector Comment					
Chain link fence with privacy slats and barbed wire within 10-ft of levee toe obstructs access and visibility.

03/16/2012 Chainlink fence with privacy slats and barbed wire obstruct visibility and access.

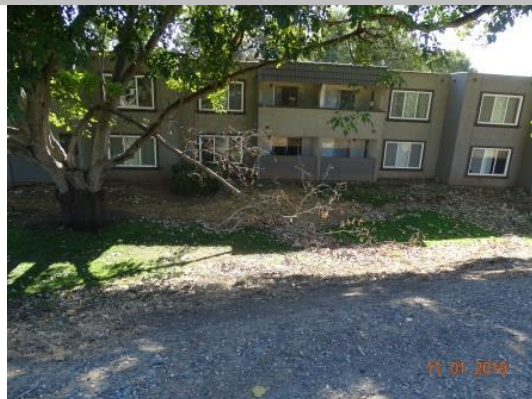
Photo 1 of 1 : SP\_2020\_NA0001\_55\_239\_20200302\_00186.jpg

LM Start	8.95	Rating **	M	Issue No.	239
LM End	8.95	Issue Type +	En	Location *	LS
Category	Earthen Levee			GPS Latitude/Longitude	
				Start	End
Item	Encroachments			38.565648 °	38.565648 °
				-121.381260 °	-121.381260 °
DWR ID	DWR_NA0001_04_s_2020_239				
Comment Code					
TR : Tree or limb					
Inspector Comment					
There is a large broken tree limb a the landside toe easement.

View of a large tree limb on the landside easement. Fall 2019

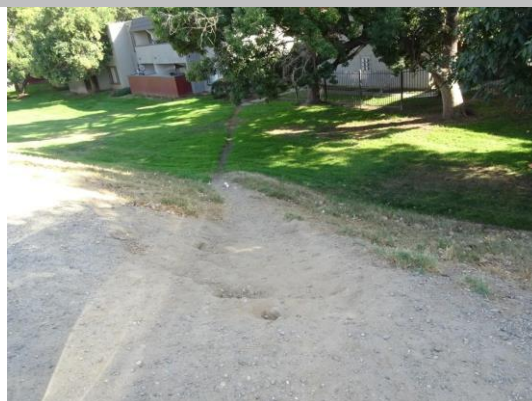
Photo 1 of 1 : SP\_2020\_NA0001\_55\_252\_20200302\_00191.jpg

LM Start	8.95	Rating **	A/W	Issue No.	252
LM End	8.95	Issue Type +	Ma	Location *	LS
Category	Earthen Levee			GPS Latitude/Longitude	
				Start	End
Item	Slope Stability			38.565696 °	38.565696 °
				-121.381141 °	-121.381141 °
DWR ID	DWR_NA0001_04_f_2018_252				
Comment Code					
S2 : Repair the levee slope damaged by foot traffic and prevent access where possible.					
Inspector Comment					
Monitor slope damage from foot traffic.

View of footpath on levee toe. Fall 2018

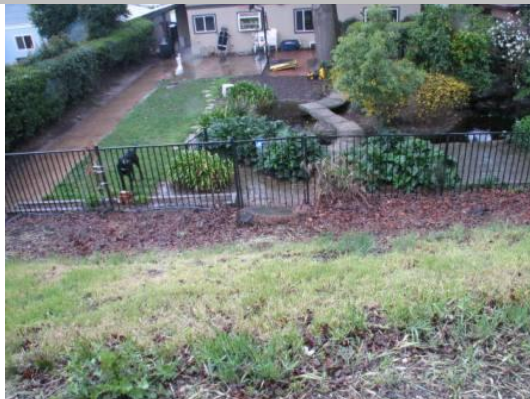
Photo 1 of 1 : SP\_2020\_NA0001\_55\_123\_20200302\_00100.jpg

LM Start	9.56	Rating **	N	Issue No.	123
LM End	9.56	Issue Type +	Ma	Location *	LS
Category	Earthen Levee			GPS Latitude/Longitude	
				Start	End
Item	Trim / Thin Trees			38.567246 °	38.567246 °
				-121.370146 °	-121.370146 °
DWR ID	DWR_NA0001_04_s_2012_123				
Comment Code					
T5 : Tree stumps.					
Inspector Comment					
Trees, tree stump, bushes, and ground cover are within 10-ft of levee toe.

03/16/2012 Large tree stump at levee toe.

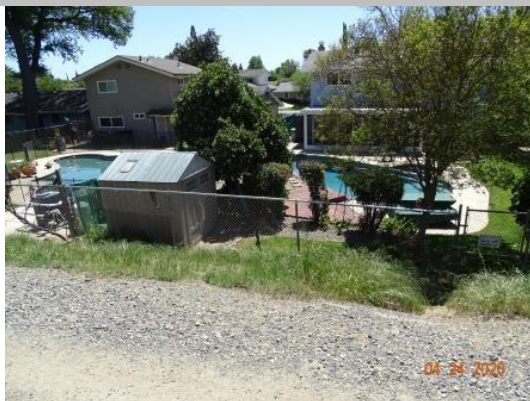
Photo 1 of 1 : SP\_2020\_NA0001\_55\_313\_20200427\_00279.jpg

LM Start	9.57	Rating **	M	Issue No.	313
LM End	9.57	Issue Type +	En	Location *	LS
Category	Earthen Levee			GPS Latitude/Longitude	
				Start	End
Item	Encroachments			38.567315 °	38.567315 °
				-121.369943 °	-121.369943 °
DWR ID	DWR_NA0001_04_s_2020_313				
Comment Code					
BU : Building					
Inspector Comment					
A shed and chainlink fence are located within 10' of the levee toe.

View of a shed and chainlink fence within 10 feet of the landside toe.  
Spring 2020

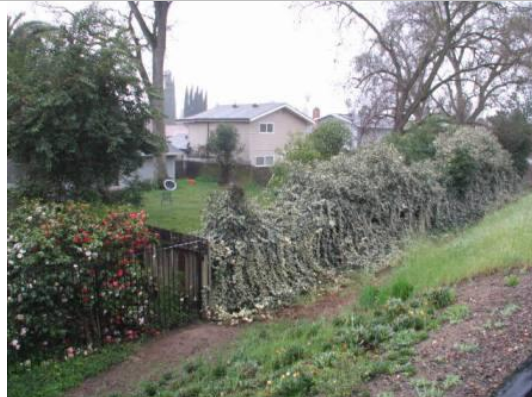
Photo 1 of 1 : SP\_2020\_NA0001\_55\_125\_20200302\_00101.jpg

LM Start	9.60	Rating **	U	Issue No.	125
LM End	9.60	Issue Type +	En	Location *	LS
Category	Earthen Levee			GPS Latitude/Longitude	
				Start	End
Item	Vegetation			38.567360 °	38.567360 °
				-121.369555 °	-121.369555 °
DWR ID	DWR_NA0001_04_s_2012_125				
Comment Code					
V6 : Landscaping					
Inspector Comment					
Dense golden ivy on chainlink fence obstructs access and visibility.

03/16/2012 Landscaping obstructs visibility and access.

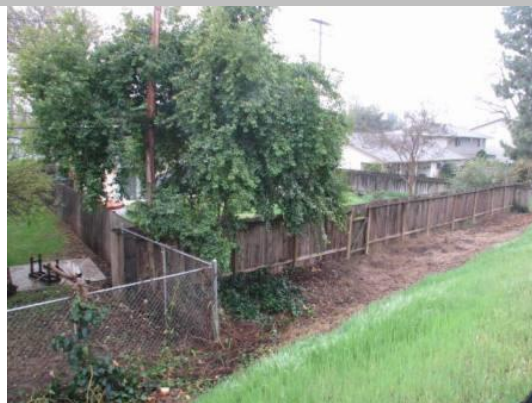
Photo 1 of 1 : SP\_2020\_NA0001\_55\_128\_20200302\_00102.jpg

LM Start	9.64	Rating **	M	Issue No.	128
LM End	9.64	Issue Type +	En	Location *	LS
Category	Earthen Levee			GPS Latitude/Longitude	
				Start	End
Item	Encroachments			38.567540 °	38.567540 °
				-121.368723 °	-121.368723 °
DWR ID	DWR_NA0001_04_s_2012_128				
Comment Code					
FE : Fence					
Inspector Comment					
Wooden privacy fence within 10-ft of levee toe partially obstructs visibility and access.

03/16/2012 Wood privacy fence completely obstructs visibility.

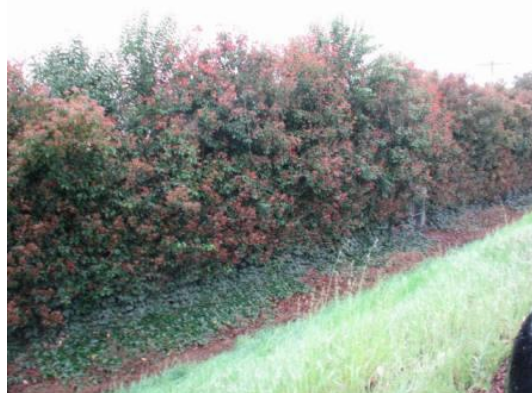
Photo 1 of 1 : SP\_2020\_NA0001\_55\_130\_20200302\_00103.jpg

LM Start	9.69	Rating **	U	Issue No.	130
LM End	9.69	Issue Type +	En	Location *	LS
Category	Earthen Levee			GPS Latitude/Longitude	
				Start	End
Item	Vegetation			38.567626 °	38.567626 °
				-121.367921 °	-121.367921 °
DWR ID	DWR_NA0001_04_s_2012_130				
Comment Code					
V6 : Landscaping					
Inspector Comment					
Tall hedge obstructs access and visibility.

03/16/2012 Tall hedge obstructs visibility and access.

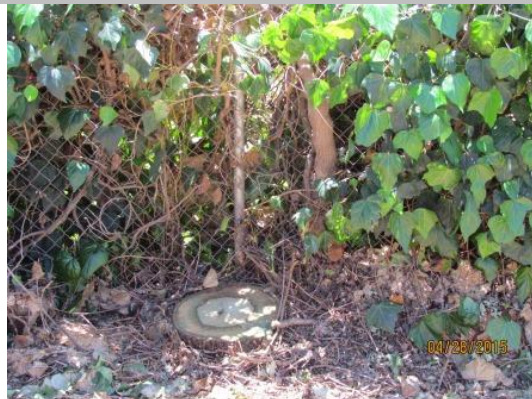
Photo 1 of 1 : SP\_2020\_NA0001\_55\_234\_20200302\_00183.jpg

LM Start	9.72	Rating **	N	Issue No.	234
LM End	9.72	Issue Type +	Ma	Location *	LS
Category	Earthen Levee			GPS Latitude/Longitude	
				Start	End
Item	Trim / Thin Trees			38.567761 °	38.567761 °
				-121.367363 °	-121.367363 °
DWR ID	DWR_NA0001_04_s_2015_234				
Comment Code					
T5 : Tree stumps.					
Inspector Comment

View of the tree stump at the landside levee toe.

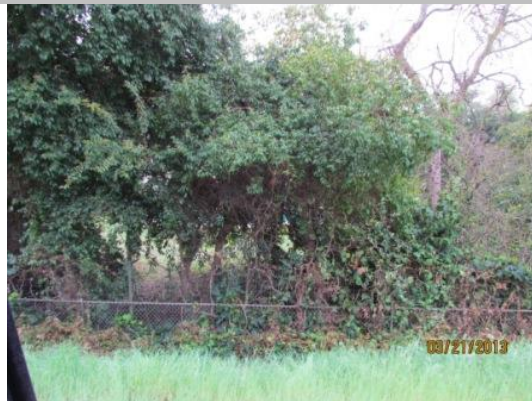
Photo 1 of 1 : SP\_2020\_NA0001\_55\_132\_20200302\_00104.jpg

LM Start	9.72	Rating **	M	Issue No.	132
LM End	9.72	Issue Type +	En	Location *	LS
Category	Earthen Levee			GPS Latitude/Longitude	
				Start	End
Item	Vegetation			38.567772 °	38.567772 °
				-121.367227 °	-121.367227 °
DWR ID	DWR_NA0001_04_s_2012_132				
Comment Code					
V6 : Landscaping					
Inspector Comment					
Trees and ivy on levee slope obstruct access and visibility.

View of obstructive landscaping.

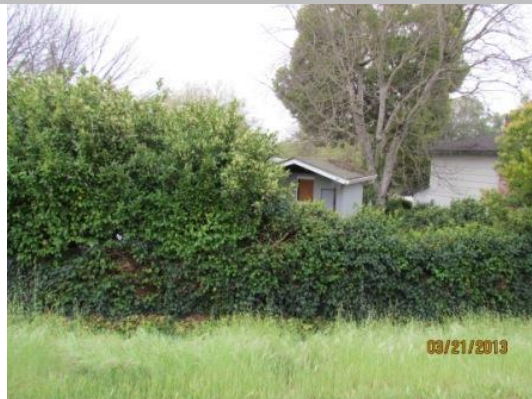
Photo 1 of 1 : SP\_2020\_NA0001\_55\_134\_20200302\_00105.jpg

LM Start	9.77	Rating **	U	Issue No.	134
LM End	9.77	Issue Type +	En	Location *	LS
Category	Earthen Levee			GPS Latitude/Longitude	
				Start	End
Item	Vegetation			38.567873 °	38.567873 °
				-121.366410 °	-121.366410 °
DWR ID	DWR_NA0001_04_s_2012_134				
Comment Code					
V6 : Landscaping					
Inspector Comment					
Ivy, hedge, and play house are within 10-ft of levee toe.

View of landscaping and playhouse that are within 10 ft. of levee toe.

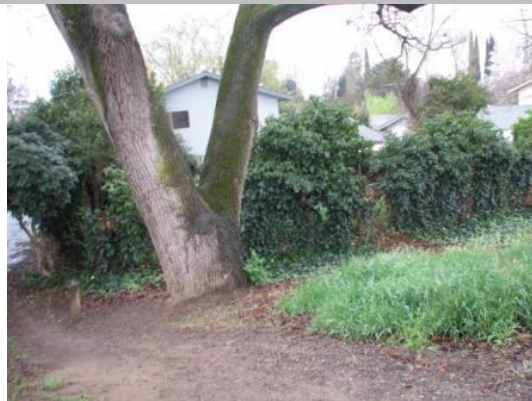
Photo 1 of 1 : SP\_2020\_NA0001\_55\_135\_20200302\_00106.jpg

LM Start	9.88	Rating **	U	Issue No.	135
LM End	9.88	Issue Type +	En	Location *	LS
Category	Earthen Levee			GPS Latitude/Longitude	
				Start	End
Item	Vegetation			38.568411 °	38.568411 °
				-121.364489 °	-121.364489 °
DWR ID	DWR_NA0001_04_s_2012_135				
Comment Code					
V6 : Landscaping					
Inspector Comment					
Tall hedge and ivy are within 10-ft of landside levee toe ramp.

03/16/2012 Landscaping is obstructing visibility.

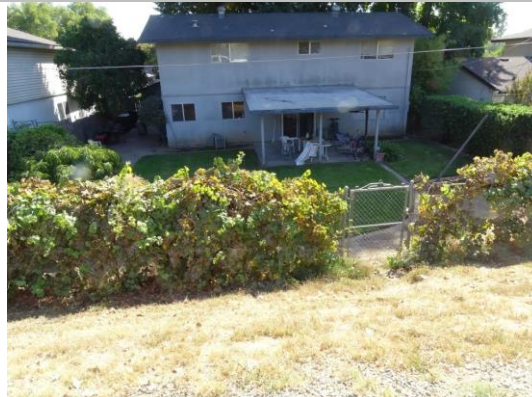
Photo 1 of 1 : SP\_2020\_NA0001\_55\_229\_20200302\_00181.jpg

LM Start	9.93	Rating **	M	Issue No.	229
LM End	9.93	Issue Type +	En	Location *	LS
Category	Earthen Levee			GPS Latitude/Longitude	
				Start	End
Item	Encroachments			38.568647 °	38.568647 °
				-121.363585 °	-121.363585 °
DWR ID	DWR_NA0001_04_s _ 2017_229				
Comment Code					
FE : Fence					
Inspector Comment					
Chainlink fence is blocking access.

View of landowner fence and vegetation blocking visibility and access.  
Fall 2018

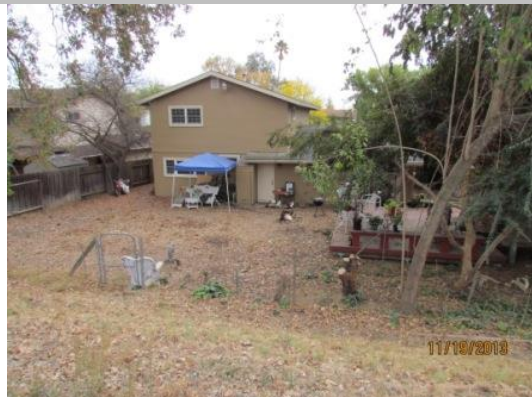
Photo 1 of 1 : SP\_2020\_NA0001\_55\_136\_20200302\_00107.jpg

LM Start	9.95	Rating **	M	Issue No.	136
LM End	9.95	Issue Type +	En	Location *	LS
Category	Earthen Levee			GPS Latitude/Longitude	
				Start	End
Item	Encroachments			38.568714 °	38.568714 °
				-121.363257 °	-121.363257 °
DWR ID	DWR_NA0001_04_s _ 2012_136				
Comment Code					
FE : Fence					
Inspector Comment					
Wire fence and vegetation are within 10-ft of landside levee toe.

View of the fence and tree stump at the landside levee toe.

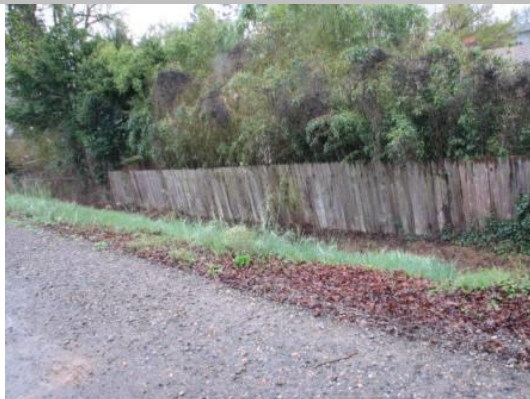
Photo 1 of 1 : SP\_2020\_NA0001\_55\_138\_20200302\_00108.jpg

LM Start	10.00	Rating **	U	Issue No.	138
LM End	10.00	Issue Type +	En	Location *	LS
Category	Earthen Levee			GPS Latitude/Longitude	
				Start	End
Item	Encroachments			38.568953 °	38.568953 °
				-121.362396 °	-121.362396 °
DWR ID	DWR_NA0001_04_s_2012_138				
Comment Code					
FE : Fence					
Inspector Comment					
Wood privacy fence completely obstructs visibility and access.

03/16/2012 Wood privacy fence completely obstructs access and visibility.

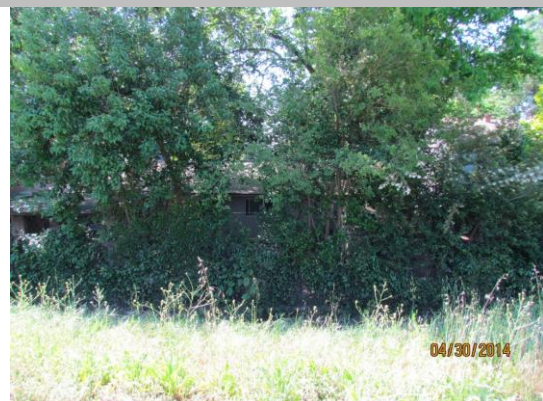
Photo 1 of 1 : SP\_2020\_NA0001\_55\_245\_20200302\_00188.jpg

LM Start	10.06	Rating **	U	Issue No.	245
LM End	10.06	Issue Type +	En	Location *	LS
Category	Earthen Levee			GPS Latitude/Longitude	
				Start	End
Item	Encroachments			38.569247 °	38.569247 °
				-121.361315 °	-121.361315 °
DWR ID	DWR_NA0001_04_s_2014_245				
Comment Code					
FE : Fence					
Inspector Comment					
Rod fence covered with vegetation is within 10ft of the levee toe.

View of the fence at the landside levee toe.

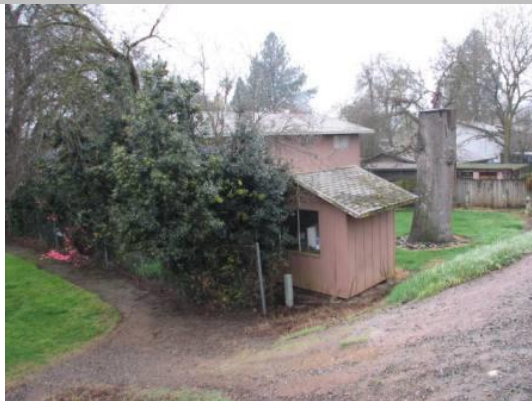
Photo 1 of 1 : SP\_2020\_NA0001\_55\_176\_20200302\_00141.jpg

LM Start	10.08	Rating **	U	Issue No.	176
LM End	10.08	Issue Type +	En	Location *	LS
Category	Earthen Levee			GPS Latitude/Longitude	
				Start	End
Item	Encroachments			38.569293 °	38.569293 °
				-121.361002 °	-121.361002 °
DWR ID	DWR_NA0001_04_s_2012_176				
Comment Code					
BU : Building					
Inspector Comment

03/16/2012 Wood structure within 15' of levee toe.

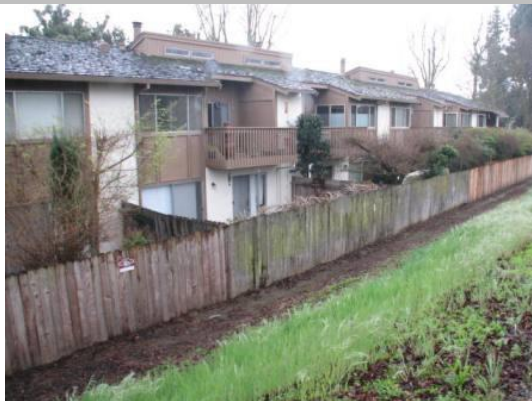
Photo 1 of 1 : SP\_2020\_NA0001\_55\_141\_20200302\_00110.jpg

LM Start	10.24	Rating **	U	Issue No.	141
LM End	10.27	Issue Type +	En	Location *	LS
Category	Earthen Levee			GPS Latitude/Longitude	
				Start	End
Item	Encroachments			38.569982 °	38.570118 °
				-121.358134 °	-121.357604 °
DWR ID	DWR_NA0001_04_s_2012_141				
Comment Code					
FE : Fence					
Inspector Comment					
Wooden fence behind six apartment units is within 10-ft of levee slope.

03/16/2012 Wood privacy fence completely obstructs access and visibility.

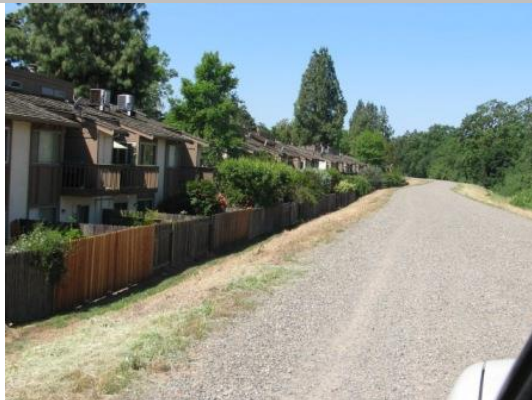
Photo 1 of 1 : SP\_2020\_NA0001\_55\_142\_20200302\_00111.jpg

LM Start	10.28	Rating **	U	Issue No.	142
LM End	10.30	Issue Type +	En	Location *	LS
Category	Earthen Levee			GPS Latitude/Longitude	
				Start	End
Item	Encroachments			38.570175 °	38.570229 °
				-121.357390 °	-121.357041 °
DWR ID	DWR_NA0001_04_s_2017_142				
Comment Code					
FE : Fence					
Inspector Comment					
Wooden fence behind six apartment units is within 10-ft of levee slope.

Wooden fence behind apartments is within 10' of levee toe.

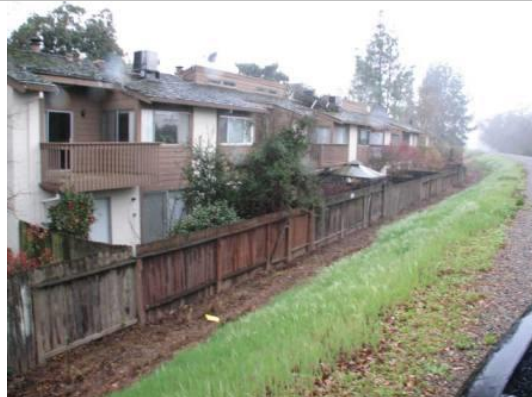
Photo 1 of 1 : SP\_2020\_NA0001\_55\_146\_20200302\_00115.jpg

LM Start	10.30	Rating **	U	Issue No.	146
LM End	10.32	Issue Type +	En	Location *	LS
Category	Earthen Levee			GPS Latitude/Longitude	
				Start	End
Item	Encroachments			38.570225 °	38.570245 °
				-121.357014 °	-121.356791 °
DWR ID	DWR_NA0001_04_s_2012_146				
Comment Code					
FE : Fence					
Inspector Comment					
Wooden fence behind six apartment units is within 10-ft of levee slope.

03/16/2012 Wood privacy fence completely obstructs access and visibility.

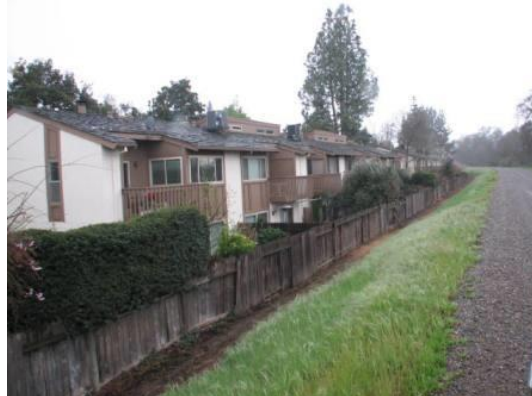
Photo 1 of 1 : SP\_2020\_NA0001\_55\_143\_20200302\_00112.jpg

LM Start	10.32	Rating **	U	Issue No.	143
LM End	10.34	Issue Type +	En	Location *	LS
Category	Earthen Levee			GPS Latitude/Longitude	
				Start	End
Item	Encroachments			38.570257 °	38.570297 °
				-121.356783 °	-121.356403 °
DWR ID	DWR_NA0001_04_f _ 2018_143				
Comment Code					
FE : Fence					
Inspector Comment					
Wooden fence behind six apartment units is within 10-ft of levee slope.

03/16/2012 Wood privacy fence completely obstructs access and visibility.

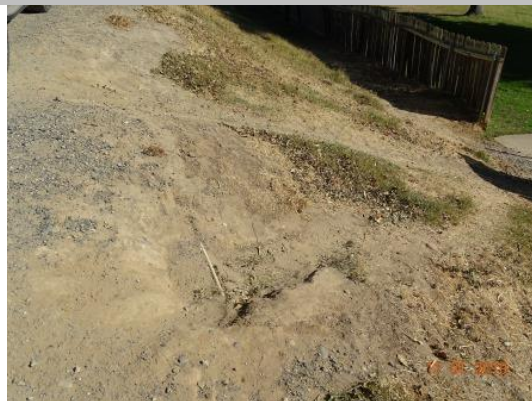
Photo 1 of 1 : SP\_2020\_NA0001\_55\_228\_20200302\_00179.jpg

LM Start	10.42	Rating **	A/W	Issue No.	228
LM End	10.42	Issue Type +	Ma	Location *	LS
Category	Earthen Levee			GPS Latitude/Longitude	
				Start	End
Item	Slope Stability			38.570536 °	38.570536 °
				-121.354957 °	-121.354957 °
DWR ID	DWR_NA0001_04_s_2016_228				
Comment Code					
S2 : Repair the levee slope damaged by foot traffic and prevent access where possible.					
Inspector Comment					
The erosion of the levee slope from the footpath appears to be stable at this time and should be monitored.

View of erosion along a footpath. Fall 2019

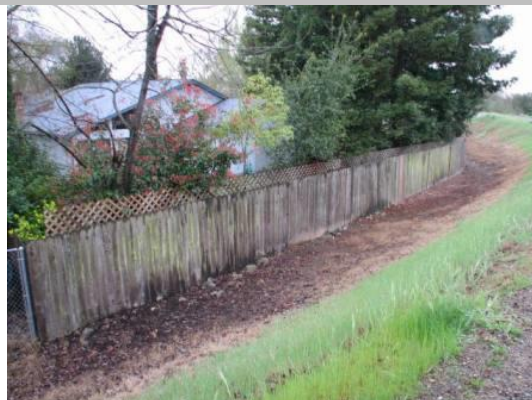
Photo 1 of 1 : SP\_2020\_NA0001\_55\_148\_20200302\_00117.jpg

LM Start	10.45	Rating **	U	Issue No.	148
LM End	10.45	Issue Type +	En	Location *	LS
Category	Earthen Levee			GPS Latitude/Longitude	
				Start	End
Item	Encroachments			38.570524 °	38.570524 °
				-121.354359 °	-121.354359 °
DWR ID	DWR_NA0001_04_s_2012_148				
Comment Code					
FE : Fence					
Inspector Comment					
A wooden privacy fence obstructs visibility and access.

03/16/2012 Wood privacy fence completely obstructs access and visibility.

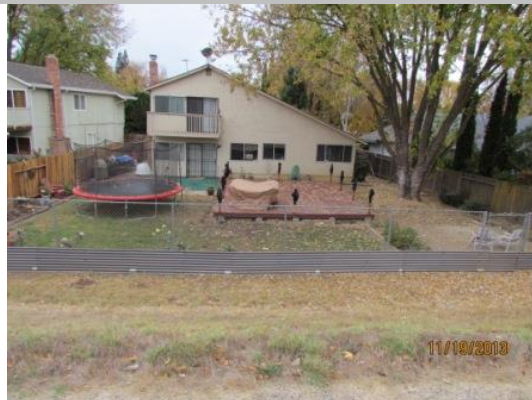
Photo 1 of 1 : SP\_2020\_NA0001\_55\_180\_20200302\_00145.jpg

LM Start	10.47	Rating **	M	Issue No.	180
LM End	10.47	Issue Type +	En	Location *	LS
Category	Earthen Levee			GPS Latitude/Longitude	
				Start	End
Item	Encroachments			38.570397 °	38.570397 °
				-121.354084 °	-121.354084 °
DWR ID	DWR_NA0001_04_s_2012_180				
Comment Code					
FE : Fence					
Inspector Comment					
A chainlink fence partially obstructs visibility.

Chainlink fence is partially obstructing visibility and access. Fall 2013

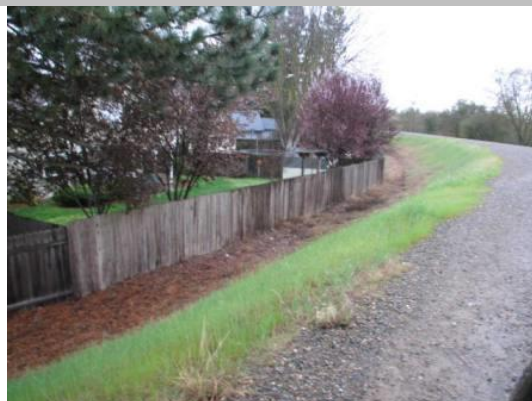
Photo 1 of 1 : SP\_2020\_NA0001\_55\_149\_20200302\_00118.jpg

LM Start	10.48	Rating **	U	Issue No.	149
LM End	10.48	Issue Type +	En	Location *	LS
Category	Earthen Levee			GPS Latitude/Longitude	
				Start	End
Item	Encroachments			38.570234 °	38.570234 °
				-121.353862 °	-121.353862 °
DWR ID	DWR_NA0001_04_s_2012_149				
Comment Code					
FE : Fence					
Inspector Comment					
Wooden privacy fence is within 10-ft of levee toe.

03/16/2012 Wood privacy fence completely obstructs access and visibility.

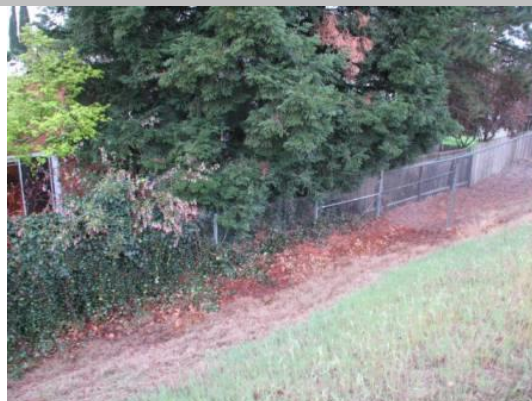
Photo 1 of 1 : SP\_2020\_NA0001\_55\_150\_20200302\_00119.jpg

LM Start	10.49	Rating **	U	Issue No.	150
LM End	10.49	Issue Type +	En	Location *	LS
Category	Earthen Levee			GPS Latitude/Longitude	
				Start	End
Item	Encroachments			38.570095 °	38.570095 °
				-121.353807 °	-121.353807 °
DWR ID	DWR_NA0001_04_s_2020_150				
Comment Code					
FE : Fence					
Inspector Comment					
A wooden privacy fence is within 10-ft of the levee toe.

03/16/2012 Wood privacy fence completely obstructs access and visibility.

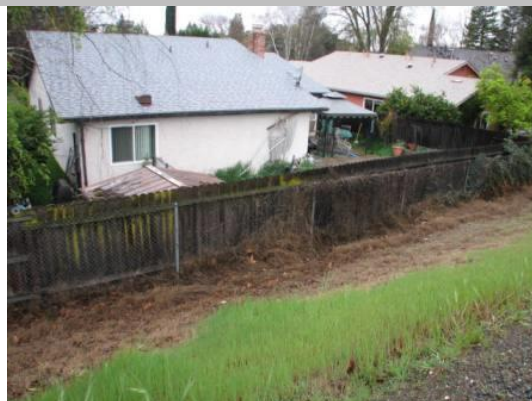
Photo 1 of 1 : SP\_2020\_NA0001\_55\_151\_20200302\_00120.jpg

LM Start	10.51	Rating **	U	Issue No.	151
LM End	10.51	Issue Type +	En	Location *	LS
Category	Earthen Levee			GPS Latitude/Longitude	
				Start	End
Item	Encroachments			38.569921 °	38.569921 °
				-121.353643 °	-121.353643 °
DWR ID	DWR_NA0001_04_s_2012_151				
Comment Code					
FE : Fence					
Inspector Comment					
A wooden privacy fence and shed are within 10-ft of the levee toe.

03/16/2012 Wood privacy fence completely obstructs access and visibility.

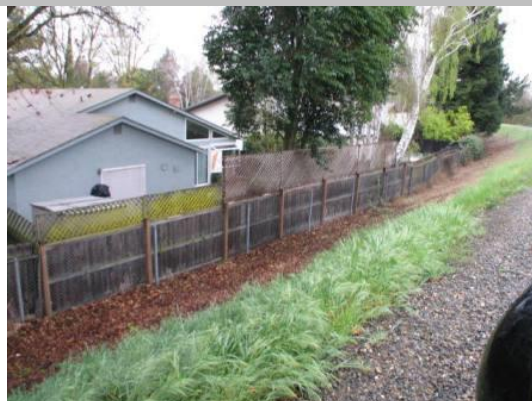
Photo 1 of 1 : SP\_2020\_NA0001\_55\_152\_20200302\_00121.jpg

LM Start	10.52	Rating **	U	Issue No.	152
LM End	10.52	Issue Type +	En	Location *	LS
Category	Earthen Levee			GPS Latitude/Longitude	
				Start	End
Item	Encroachments			38.569758 °	38.569758 °
				-121.353535 °	-121.353535 °
DWR ID	DWR_NA0001_04_s_2012_152				
Comment Code					
FE : Fence					
Inspector Comment					
A wooden privacy fence is within 10-ft of the levee toe.

03/16/2012 Wood privacy fence completely obstructs access and visibility.

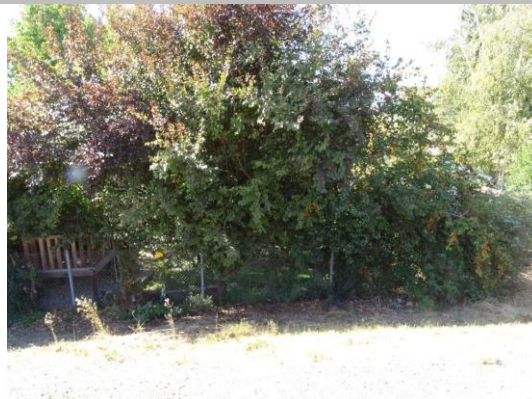
Photo 1 of 1 : SP\_2020\_NA0001\_55\_217\_20200302\_00173.jpg

LM Start	10.56	Rating **	M	Issue No.	217
LM End	10.56	Issue Type +	En	Location *	LS
Category	Earthen Levee			GPS Latitude/Longitude	
				Start	End
Item	Vegetation			38.569296 °	38.569296 °
				-121.353365 °	-121.353365 °
DWR ID	DWR_NA0001_04_f_2018_217				
Comment Code					
V6 : Landscaping					
Inspector Comment					
Trees and bushes block visibility of the levee toe. The shed is also on the levee toe.

View of landowner vegetation blocking visibility of levee toe. Fall 2018

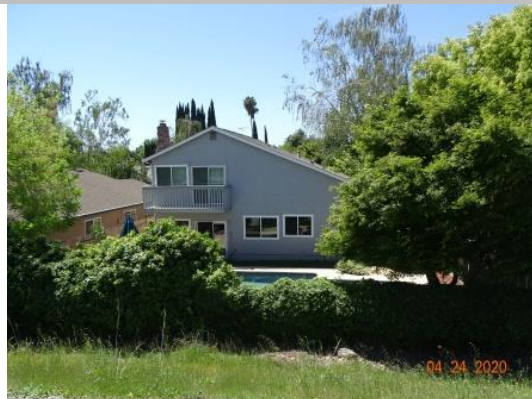
Photo 1 of 1 : SP\_2020\_NA0001\_55\_153\_20200427\_00280.jpg

LM Start	10.57	Rating **	U	Issue No.	153
LM End	10.57	Issue Type +	En	Location *	LS
Category	Earthen Levee			GPS Latitude/Longitude	
				Start	End
Item	Encroachments			38.569166 °	38.569166 °
				-121.353272 °	-121.353272 °
DWR ID	DWR_NA0001_04_s_2012_153				
Comment Code					
FE : Fence					
Inspector Comment					
A fence with ivy within 10-ft of the levee toe blocks visibility. The pool does not appear to be authorized.

View of a fence with ivy that blocks visibility. The pool does not appear to be authorized. Spring 2020

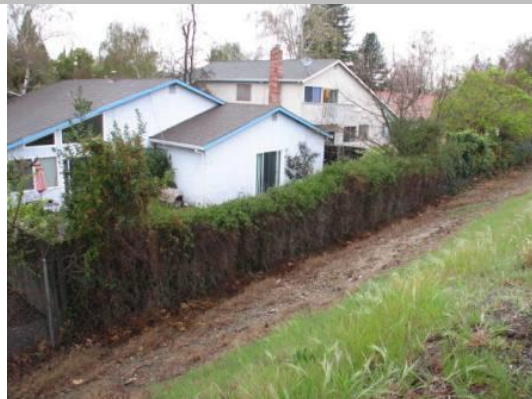
Photo 1 of 1 : SP\_2020\_NA0001\_55\_154\_20200302\_00123.jpg

LM Start	10.58	Rating **	U	Issue No.	154
LM End	10.58	Issue Type +	En	Location *	LS
Category	Earthen Levee			GPS Latitude/Longitude	
				Start	End
Item	Encroachments			38.569013 °	38.569013 °
				-121.353218 °	-121.353218 °
DWR ID	DWR_NA0001_04_s_2012_154				
Comment Code					
FE : Fence					
Inspector Comment					
A wooden privacy fence with landscaping is within 10-ft of the levee toe.

03/16/2012 Wood privacy fence completely obstructs access and visibility.

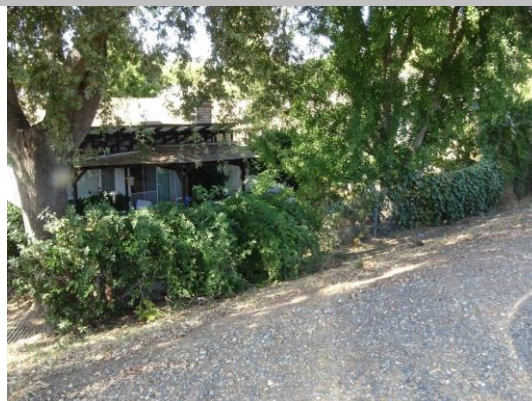
Photo 1 of 1 : SP\_2020\_NA0001\_55\_155\_20200302\_00124.jpg

LM Start	10.59	Rating **	M	Issue No.	155
LM End	10.59	Issue Type +	En	Location *	LS
Category	Earthen Levee			GPS Latitude/Longitude	
				Start	End
Item	Vegetation			38.568892 °	38.568892 °
				-121.353162 °	-121.353162 °
DWR ID	DWR_NA0001_04_s_2019_155				
Comment Code					
V6 : Landscaping					
Inspector Comment					
Trees and bushes are within 10-ft of the levee toe and block visibility.

View of tree and bushes within levee easement. Fall 2018

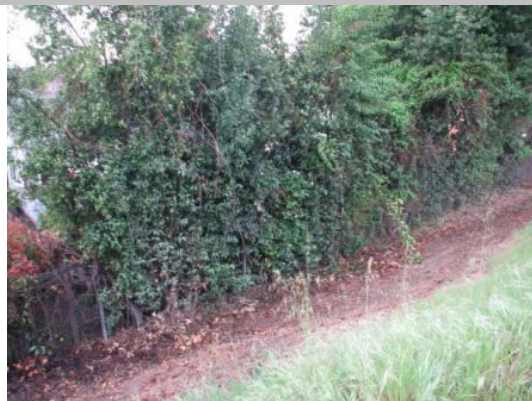
Photo 1 of 1 : SP\_2020\_NA0001\_55\_157\_20200302\_00125.jpg

LM Start	10.61	Rating **	M	Issue No.	157
LM End	10.61	Issue Type +	En	Location *	LS
Category	Earthen Levee			GPS Latitude/Longitude	
				Start	End
Item	Vegetation			38.568608 °	38.568608 °
				-121.353054 °	-121.353054 °
DWR ID	DWR_NA0001_04_s_2012_157				
Comment Code					
V6 : Landscaping					
Inspector Comment					
A tall hedge and vines are on the levee toe.

03/16/2012 Landscaping obstructs visibility.

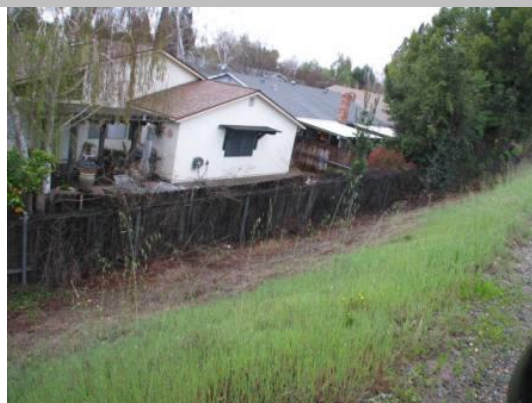
Photo 1 of 1 : SP\_2020\_NA0001\_55\_158\_20200302\_00126.jpg

LM Start	10.62	Rating **	U	Issue No.	158
LM End	10.62	Issue Type +	En	Location *	LS
Category	Earthen Levee			GPS Latitude/Longitude	
				Start	End
Item	Encroachments			38.568355 °	38.568355 °
				-121.353033 °	-121.353033 °
DWR ID	DWR_NA0001_04_s_2012_158				
Comment Code					
FE : Fence					
Inspector Comment					
A wooden privacy fence is within 10-ft of the levee toe.

03/16/2012 Wood privacy fence completely obstructs access and visibility.

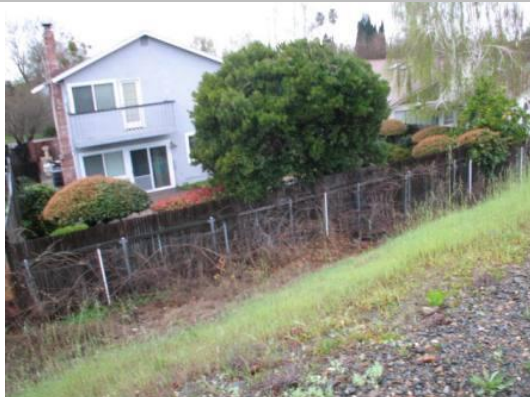
Photo 1 of 1 : SP\_2020\_NA0001\_55\_159\_20200302\_00127.jpg

LM Start	10.63	Rating **	U	Issue No.	159
LM End	10.63	Issue Type +	En	Location *	LS
Category	Earthen Levee			GPS Latitude/Longitude	
				Start	End
Item	Encroachments			38.568313 °	38.568313 °
				-121.352941 °	-121.352941 °
DWR ID	DWR_NA0001_04_s_2012_159				
Comment Code					
FE : Fence					
Inspector Comment					
A wooden privacy fence is within 10-ft of the levee toe. The pool does not appear to be authorized.

03/16/2012 Wood privacy fence completely obstructs access and visibility.

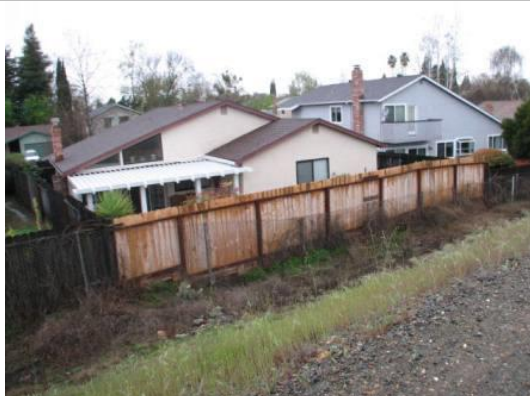
Photo 1 of 1 : SP\_2020\_NA0001\_55\_160\_20200302\_00128.jpg

LM Start	10.64	Rating **	U	Issue No.	160
LM End	10.64	Issue Type +	En	Location *	LS
Category	Earthen Levee			GPS Latitude/Longitude	
				Start	End
Item	Encroachments			38.568188 °	38.568188 °
				-121.352864 °	-121.352864 °
DWR ID	DWR_NA0001_04_f_2012_160				
Comment Code					
FE : Fence					
Inspector Comment					
A tall wooden privacy fence is within 10-ft of the levee toe.

03/16/2012 Wood privacy fence completely obstructs access and visibility.

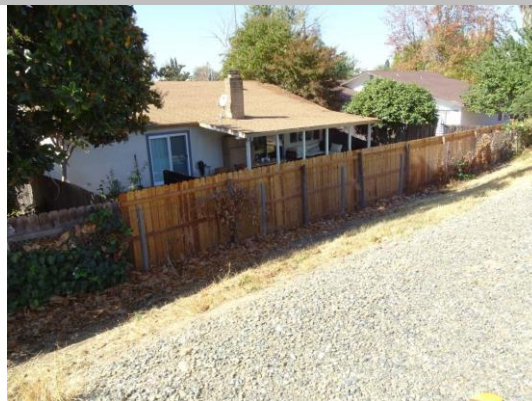
Photo 1 of 1 : SP\_2020\_NA0001\_55\_162\_20200302\_00130.jpg

LM Start	10.70	Rating **	U	Issue No.	162
LM End	10.70	Issue Type +	En	Location *	LS
Category	Earthen Levee			GPS Latitude/Longitude	
				Start	End
Item	Encroachments			38.567402 °	38.567402 °
				-121.352415 °	-121.352415 °
DWR ID	DWR_NA0001_04_s_2012_162				
Comment Code					
FE : Fence					
Inspector Comment					
A wooden and chainlink fence is within 10-ft of the levee toe.

View of wooden fence at levee toe that blocks visibility. Fall 2018

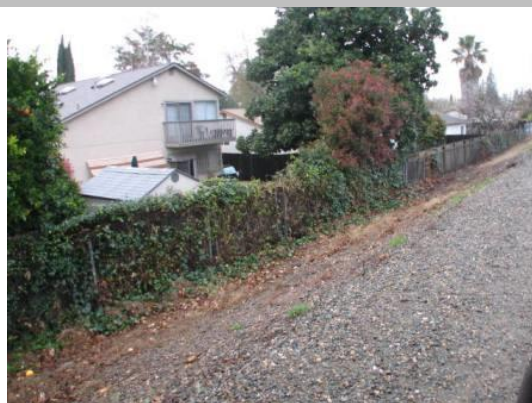
Photo 1 of 1 : SP\_2020\_NA0001\_55\_163\_20200302\_00131.jpg

LM Start	10.71	Rating **	U	Issue No.	163
LM End	10.71	Issue Type +	En	Location *	LS
Category	Earthen Levee			GPS Latitude/Longitude	
				Start	End
Item	Encroachments			38.567250 °	38.567250 °
				-121.352341 °	-121.352341 °
DWR ID	DWR_NA0001_04_s_2012_163				
Comment Code					
FE : Fence					
Inspector Comment					
A wooden privacy fence and landscaping are within 10-ft of the levee toe.

03/16/2012 Wood privacy fence completely obstructs access and visibility.

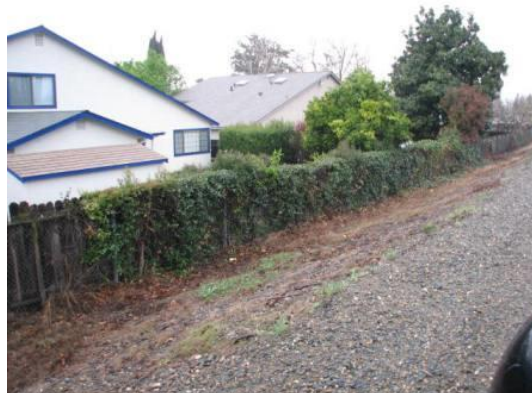
Photo 1 of 1 : SP\_2020\_NA0001\_55\_172\_20200302\_00139.jpg

LM Start	10.72	Rating **	U	Issue No.	172
LM End	10.72	Issue Type +	En	Location *	LS
Category	Earthen Levee			GPS Latitude/Longitude	
				Start	End
Item	Encroachments			38.567008 °	38.567008 °
				-121.352226 °	-121.352226 °
DWR ID	DWR_NA0001_04_s_2012_172				
Comment Code					
FE : Fence					
Inspector Comment					
A wooden privacy fence obstructs access and visibility. A shed also is located within 10' of the levee toe.

03/16/2012 Wood privacy fence completely obstructs access and visibility.

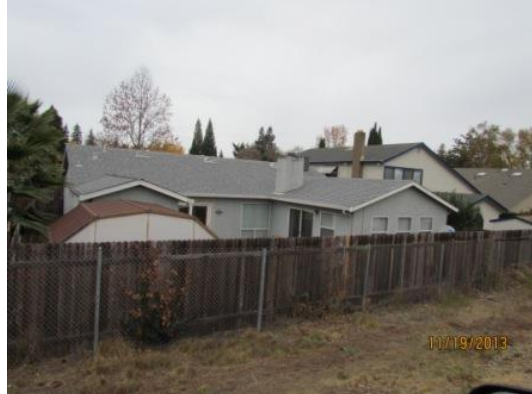
Photo 1 of 1 : SP\_2020\_NA0001\_55\_170\_20200302\_00137.jpg

LM Start	10.73	Rating **	U	Issue No.	170
LM End	10.73	Issue Type +	En	Location *	LS
Category	Earthen Levee			GPS Latitude/Longitude	
				Start	End
Item	Encroachments			38.566981 °	38.566981 °
				-121.352213 °	-121.352213 °
DWR ID	DWR_NA0001_04_f_2012_170				
Comment Code					
FE : Fence					
Inspector Comment					
A wooden privacy fence is within 10-ft of the levee toe.

View of the fence obstructing visibility and access.

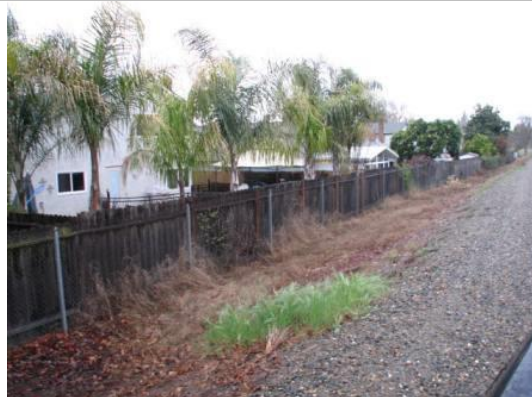
Photo 1 of 1 : SP\_2020\_NA0001\_55\_166\_20200302\_00133.jpg

LM Start	10.75	Rating **	U	Issue No.	166
LM End	10.75	Issue Type +	En	Location *	LS
Category	Earthen Levee			GPS Latitude/Longitude	
				Start	End
Item	Encroachments			38.566705 °	38.566705 °
				-121.352063 °	-121.352063 °
DWR ID	DWR_NA0001_04_s_2012_166				
Comment Code					
FE : Fence					
Inspector Comment					
A wooden privacy fence is within 10-ft of the levee toe.

03/16/2012 Wood privacy fence completely obstructs access and visibility.

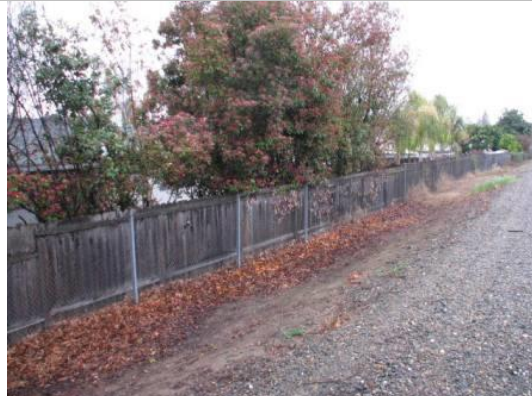
Photo 1 of 1 : SP\_2020\_NA0001\_55\_171\_20200302\_00138.jpg

LM Start	10.76	Rating **	U	Issue No.	171
LM End	10.76	Issue Type +	En	Location *	LS
Category	Earthen Levee			GPS Latitude/Longitude	
				Start	End
Item	Encroachments			38.566499 °	38.566499 °
				-121.351952 °	-121.351952 °
DWR ID	DWR_NA0001_04_s_2012_171				
Comment Code					
FE : Fence					
Inspector Comment					
A wooden privacy fence and tall hedge are within 10-ft of the levee toe.

03/16/2012 Wood privacy fence completely obstructs access and visibility.

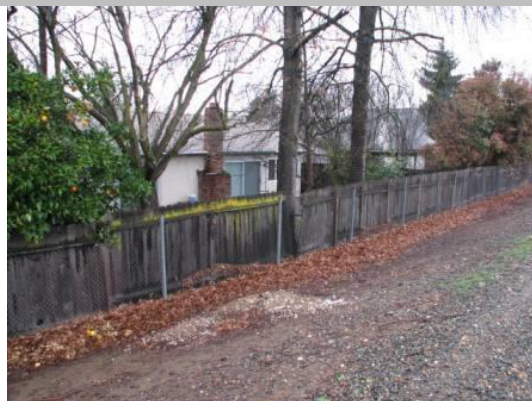
Photo 1 of 1 : SP\_2020\_NA0001\_55\_169\_20200302\_00136.jpg

LM Start	10.77	Rating **	U	Issue No.	169
LM End	10.77	Issue Type +	En	Location *	LS
Category	Earthen Levee			GPS Latitude/Longitude	
				Start	End
Item	Encroachments			38.566399 °	38.566399 °
				-121.351931 °	-121.351931 °
DWR ID	DWR_NA0001_04_s_2012_169				
Comment Code					
FE : Fence					
Inspector Comment					
A wooden privacy fence is within 10-ft of the levee toe.

03/16/2012 Wood privacy fence completely obstructs access and visibility.

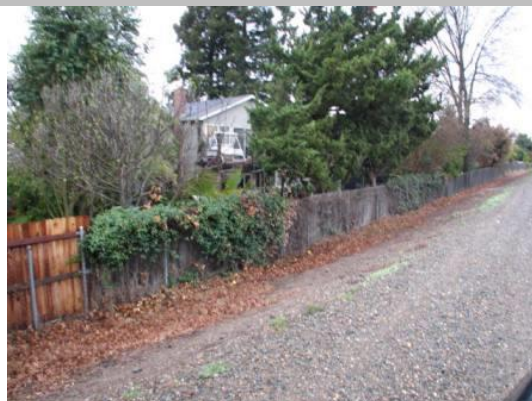
Photo 1 of 1 : SP\_2020\_NA0001\_55\_167\_20200302\_00134.jpg

LM Start	10.78	Rating **	U	Issue No.	167
LM End	10.78	Issue Type +	En	Location *	LS
Category	Earthen Levee			GPS Latitude/Longitude	
				Start	End
Item	Vegetation			38.566233 °	38.566233 °
				-121.351848 °	-121.351848 °
DWR ID	DWR_NA0001_04_s_2012_167				
Comment Code					
V6 : Landscaping					
Inspector Comment					
A wooden privacy fence, palm tree, and wooden playhouse are within 10-ft of the levee toe.

03/16/2012 Wood privacy fence completely obstructs access and visibility.

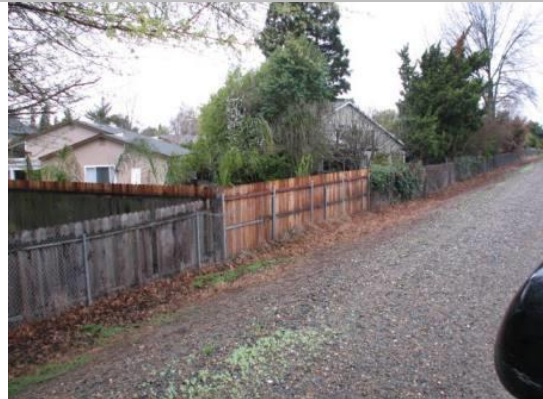
Photo 1 of 1 : SP\_2020\_NA0001\_55\_165\_20200302\_00132.jpg

LM Start	10.80	Rating **	U	Issue No.	165
LM End	10.80	Issue Type +	En	Location *	LS
Category	Earthen Levee			GPS Latitude/Longitude	
				Start	End
Item	Encroachments			38.566044 °	38.566044 °
				-121.351747 °	-121.351747 °
DWR ID	DWR_NA0001_04_s_2012_165				
Comment Code					
FE : Fence					
Inspector Comment					
A wooden privacy fence is within 10-ft of the levee toe.

03/16/2012 Wood privacy fence completely obstructs access and visibility.

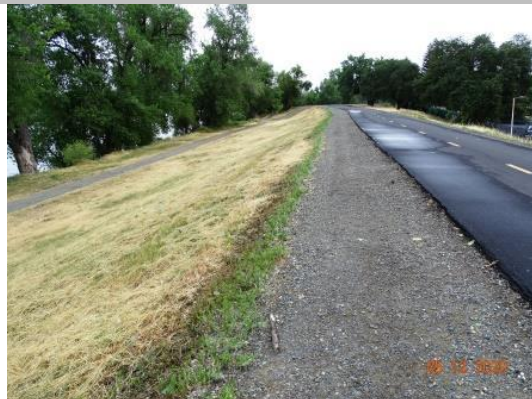
Photo 1 of 1 : SP\_2020\_NA0001\_56\_1\_20200512\_00003.jpg

LM Start	0.00	Rating **	A	Issue No.	1
LM End	0.40	Issue Type +	Ma	Location *	WS
Category	Earthen Levee			GPS Latitude/Longitude	
				Start	End
Item	Vegetation			38.596400 °	38.590807 °
				-121.506925 °	-121.505313 °
DWR ID	DWR_NA0001_05_s_2020_1				
Comment Code					
V1 : Control annual grass and weeds on the levee slopes and easements.					
Inspector Comment					
The annual vegetation on the waterside slope is well-maintained.

View of well-maintained annual vegetation on the waterside slope.  
Spring 2020

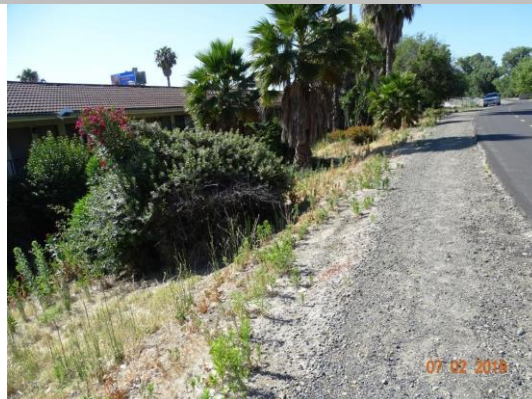
Photo 1 of 2 : SP\_2020\_NA0001\_56\_2\_20200302\_00001.jpg

LM Start	0.10	Rating **	U	Issue No.	2
LM End	0.17	Issue Type +	En	Location *	LS
Category	Earthen Levee			GPS Latitude/Longitude	
				Start	End
Item	Vegetation			38.595044 °	38.594117 °
				-121.506497 °	-121.506377 °
DWR ID	DWR_NA0001_05_s_2012_2				
Comment Code					
V6 : Landscaping					
Inspector Comment					
Notice to Comply, NC2018-301, was issued on 07/02/2019, for Best Western to maintain landscaping per permit 8760.

View of the landscaping on the landside levee slope documented under FIR.
